# Manhole Inspection Summary

Manhole # S55O\_\_029MH

Insp Date: **7/28/08 9:22 AM**

**Location** Address: **1211 s conkling st**

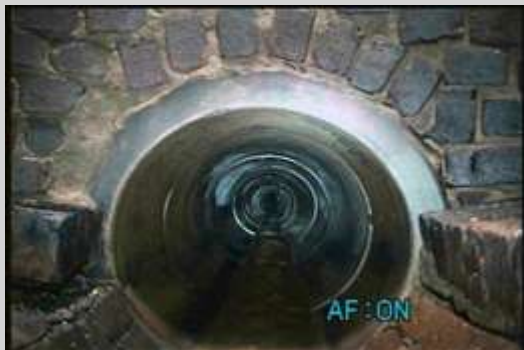
12 O'Clock Outflow

24 in. Circular Gravity Sewer  
Pipe Out @ 12 O'Clock

Invert Depth: 11.63 (ft.) Flow Characteristics: **Slow**

Deposits: ☒ None ☐ Mud ☐ Sludge ☐ Debris ☐ Grease

Infiltration: **None** Pipe Seal Cond: **Unknown**

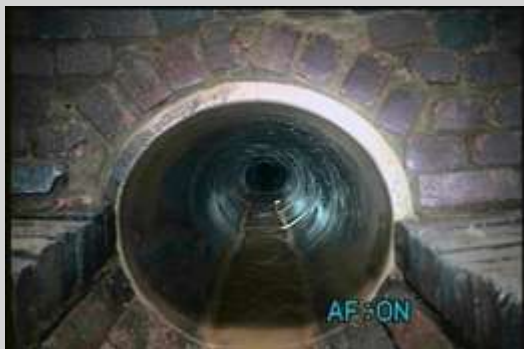
6 O'Clock Inflow

24 in. Circular Gravity Sewer  
Pipe In @ 6 O'Clock

Invert Depth: 11.54 (ft.) Flow Characteristics: **Slow**

Deposits: ☒ None ☐ Mud ☐ Sludge ☐ Debris ☐ Grease

Infiltration: **None** Pipe Seal Cond: **Unknown**

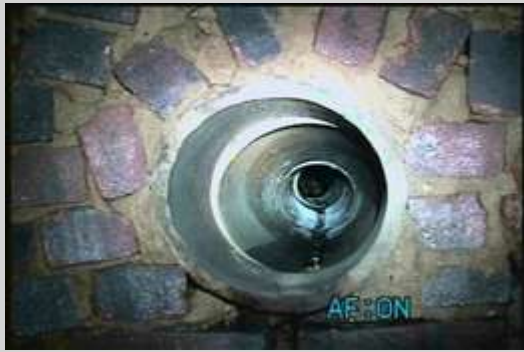
7 O'Clock Inflow

8 in. Circular Gravity Sewer

Pipe In @ 7 O'Clock

Invert Depth: **9.20** (ft.) Flow Characteristics: **None**

Deposits: ☒ None ☐ Mud ☐ Sludge ☐ **Debris** ☐ Grease

Infiltration: **None**

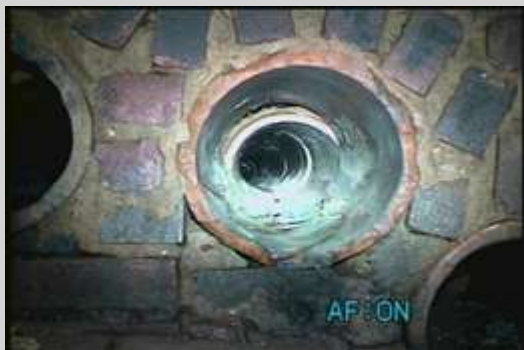
8 O'Clock Inflow

8 in. Circular Gravity Sewer

Pipe In @ 8 O'Clock

Pipe Material: **Clay** ☐ Pipe Lined
